SHELTER ELECTRICAL EQUIPMENT S-318()/G - FINAL REPORT

Report No. 13

Contract No. DA-36-039-SC-90814(E)

From: Twin Industries Corporation  
Special Products Division  
P.O. Box 68  
Sayre, Pennsylvania

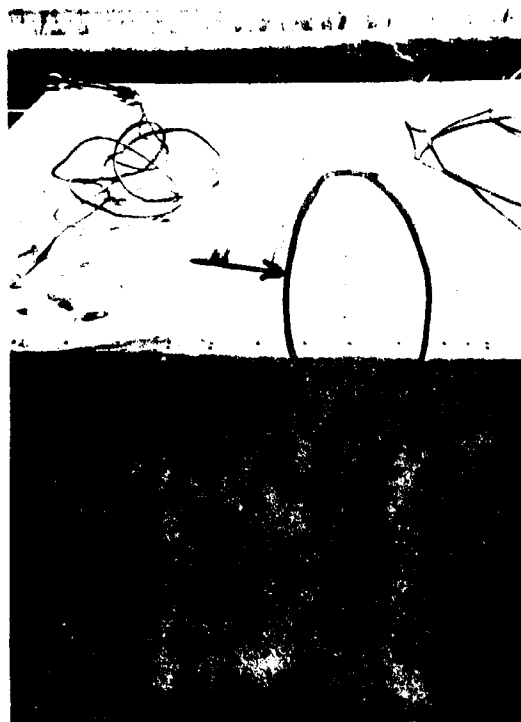
FIG. 1 AREA SHOWING THREE WELD POINTS IN SHELTER ROOF OPENED AS RESULT OF R.R. HUMMING TEST WITH SHELTER SECURED IN LATERAL POSITION ON FLATCAR.

After careful evaluation, it was decided that the damage which occurred during the second and third railroad impact could be attributed to unsatisfactory welding and that the failure of the lower door frame to absorb the load caused considerable damage to the rear panel.
